Manhole Inspection Summary

Manhole # S2100_001MH

Location Address: **2323 OREM AVE**

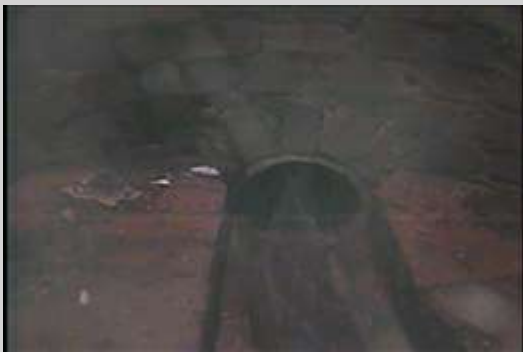
12 O'Clock Outflow

8 in. Circular Gravity Sewer
Pipe Out @ 12 O'Clock

Pipe Height: **8.4** (in.) Rod and Bar (Angled)
Pipe Material: **Clay** ☐ Pipe Lined
Invert Depth: **10.74** (ft.) Flow Characteristics: **Slow**
Deposits: ☒ None ☐ Mud ☐ Sludge ☐ Debris ☐ Grease
Silt Depth: (in.) Deposits Extent:
Infiltration: **None** Pipe Seal Cond: **Sound**
